MINING SEARCH: METALLIFEROUS MINERALS

This desk-top search, which is based on maps, plans and records, is an assessment of the risk of subsidence to the property associated with historic extractive metal mining.

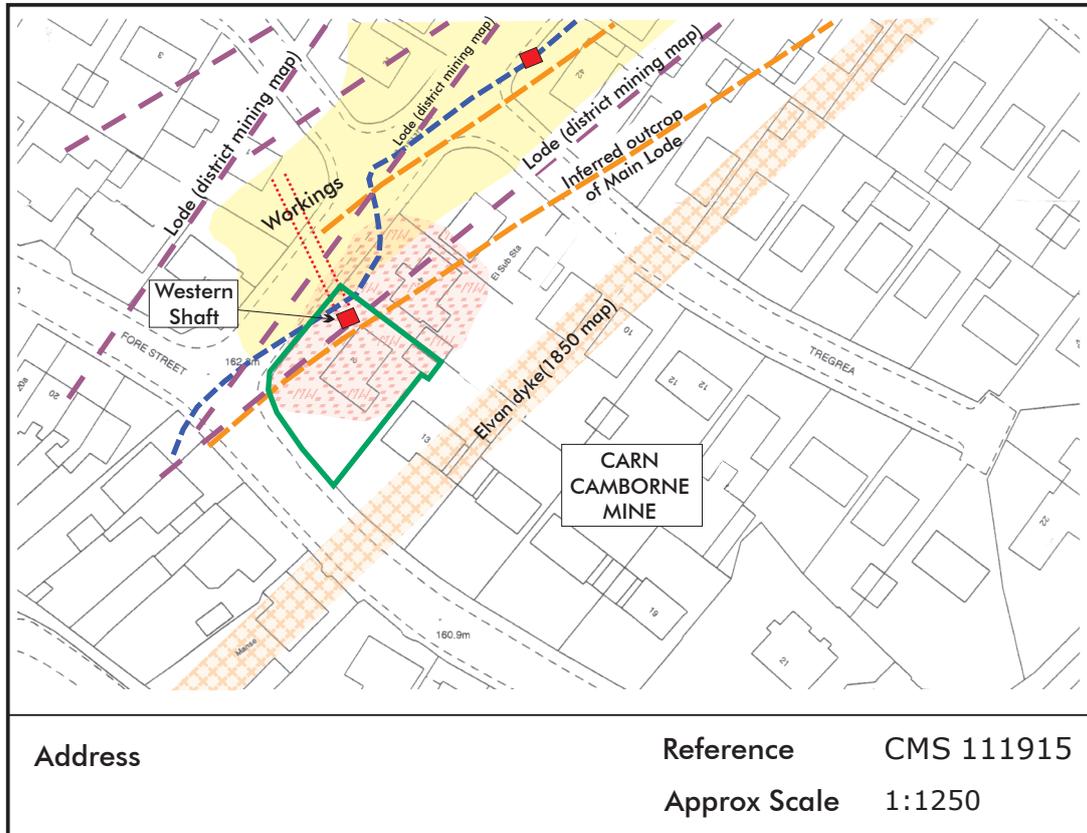
- Property boundary
- Recorded lode
- Inferred lode outcrop
- Inferred lode outcrop zone
- Adit
- Crosscourse
- Elvan dyke
- Shaft
- Mine waste
- Surface/opencast working
- Stone quarry

Activity at Carn Camborne Mine was concentrated on two lodes called Main, or South Lode, and North Lode, both of which traverse the locality in a general northeast-southwest direction in the vicinity. Other lodes are also recorded to the north of the property. Several shafts were sunk along these lodes of which the westernmost shaft, named Western Shaft, lies within the northern corner of the property, adjacent to the dwelling. This shaft follows the underlie of Main Lode to a total depth of 110 metres (the dimensional size of the shaft is not recorded). The shallowest recorded working is the drainage tunnel (adit) which has been driven along Main Lode and lies at a depth of approximately 40 metres in the vicinity of the property. The mine plans show the adit level on Main Lode to lie under the northern part of the property. To the north of the property the adit cuts northwards to intersect a parallel lode 15 metres north of Main Lode.

Western Shaft has to be considered to be a potentially hazardous feature, unless it has been properly secured. Upon abandonment of a mine it was common practice to either place a capping of timber over the shaft mouth or to backfill the shaft with mine waste. With the passing of time the site of the shaft may become obliterated and forgotten. However, timber will decay and may lead to a catastrophic subsidence if the cap collapses, or backfill may slump leading to a more gradual subsidence. The size of the depression caused by a subsidence of this type depends upon the condition of the shaft collar and the nature and depth of the overburden surrounding it. A shaft can only be considered secure if it has been properly plugged at bedrock level with mass or reinforced concrete. It is possible that the shaft has been adequately secured, but we hold no records regarding any ground works that may have been carried out.

Based on the available documentary evidence, we are unable to provide an assurance that the property will not be affected by subsidence caused by historic extractive mining. Western Shaft is recorded within the northern corner of the property, close to the dwelling. This shaft has to be considered to be a potential hazard unless it has been secured. In addition there is a risk of localised subsidence from unrecorded shallow workings along the outcrop of Main Lode within the northern part of the property.
